BUREAU OF SHIPS

TECHNICAL INSPECTION REPORT

⑥ OPERATION CROSSROADS.
U.S.S. PENSACOLA (CA24).

TEST BAKER.

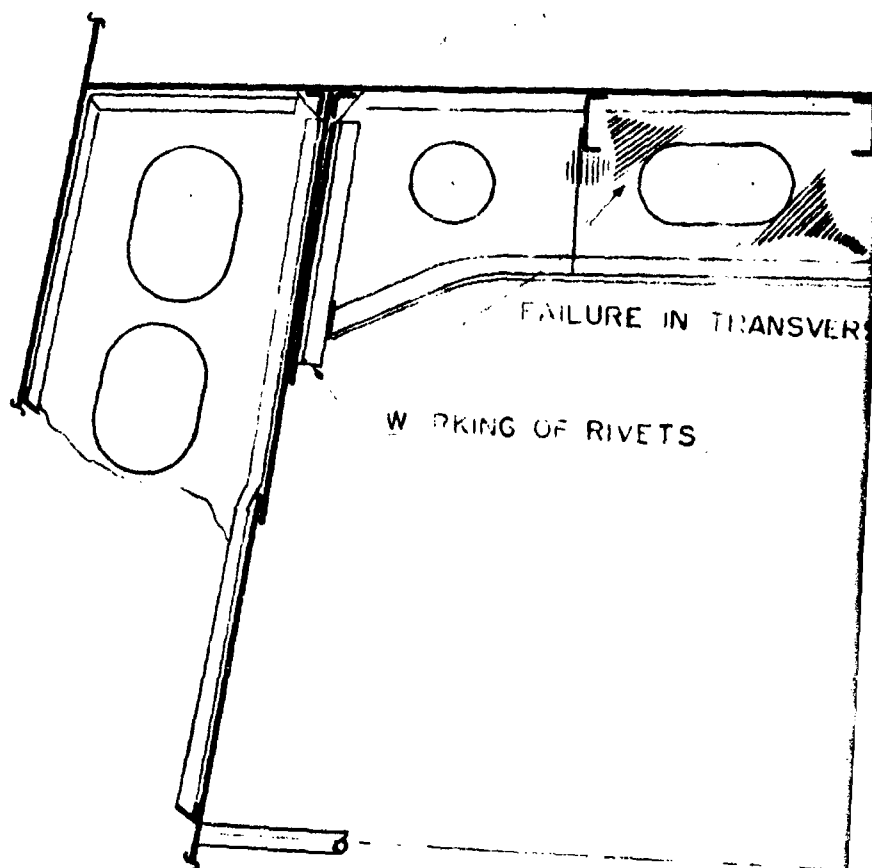
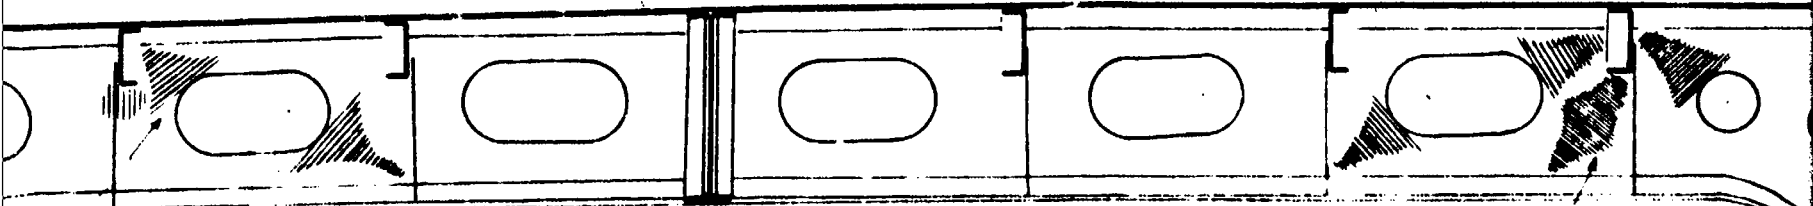
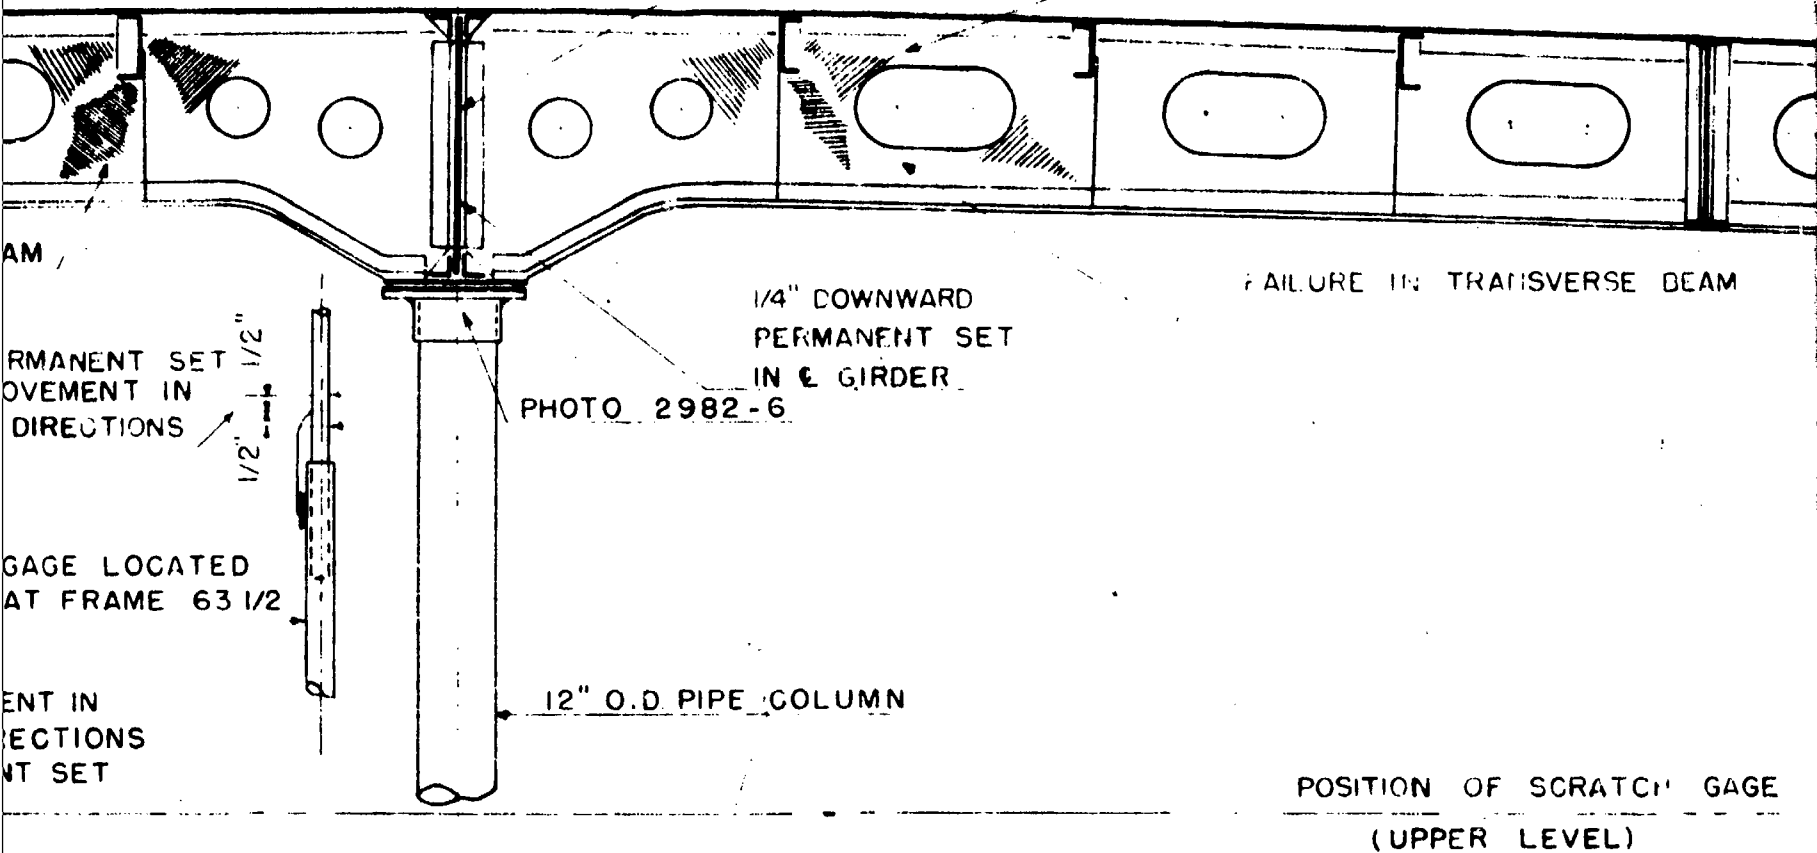
PHOTO 2982-9

FAILURE IN TRANSVERSE BEAM

FR. 64 , LOOKING FWD., FWD. ENGINE RM.

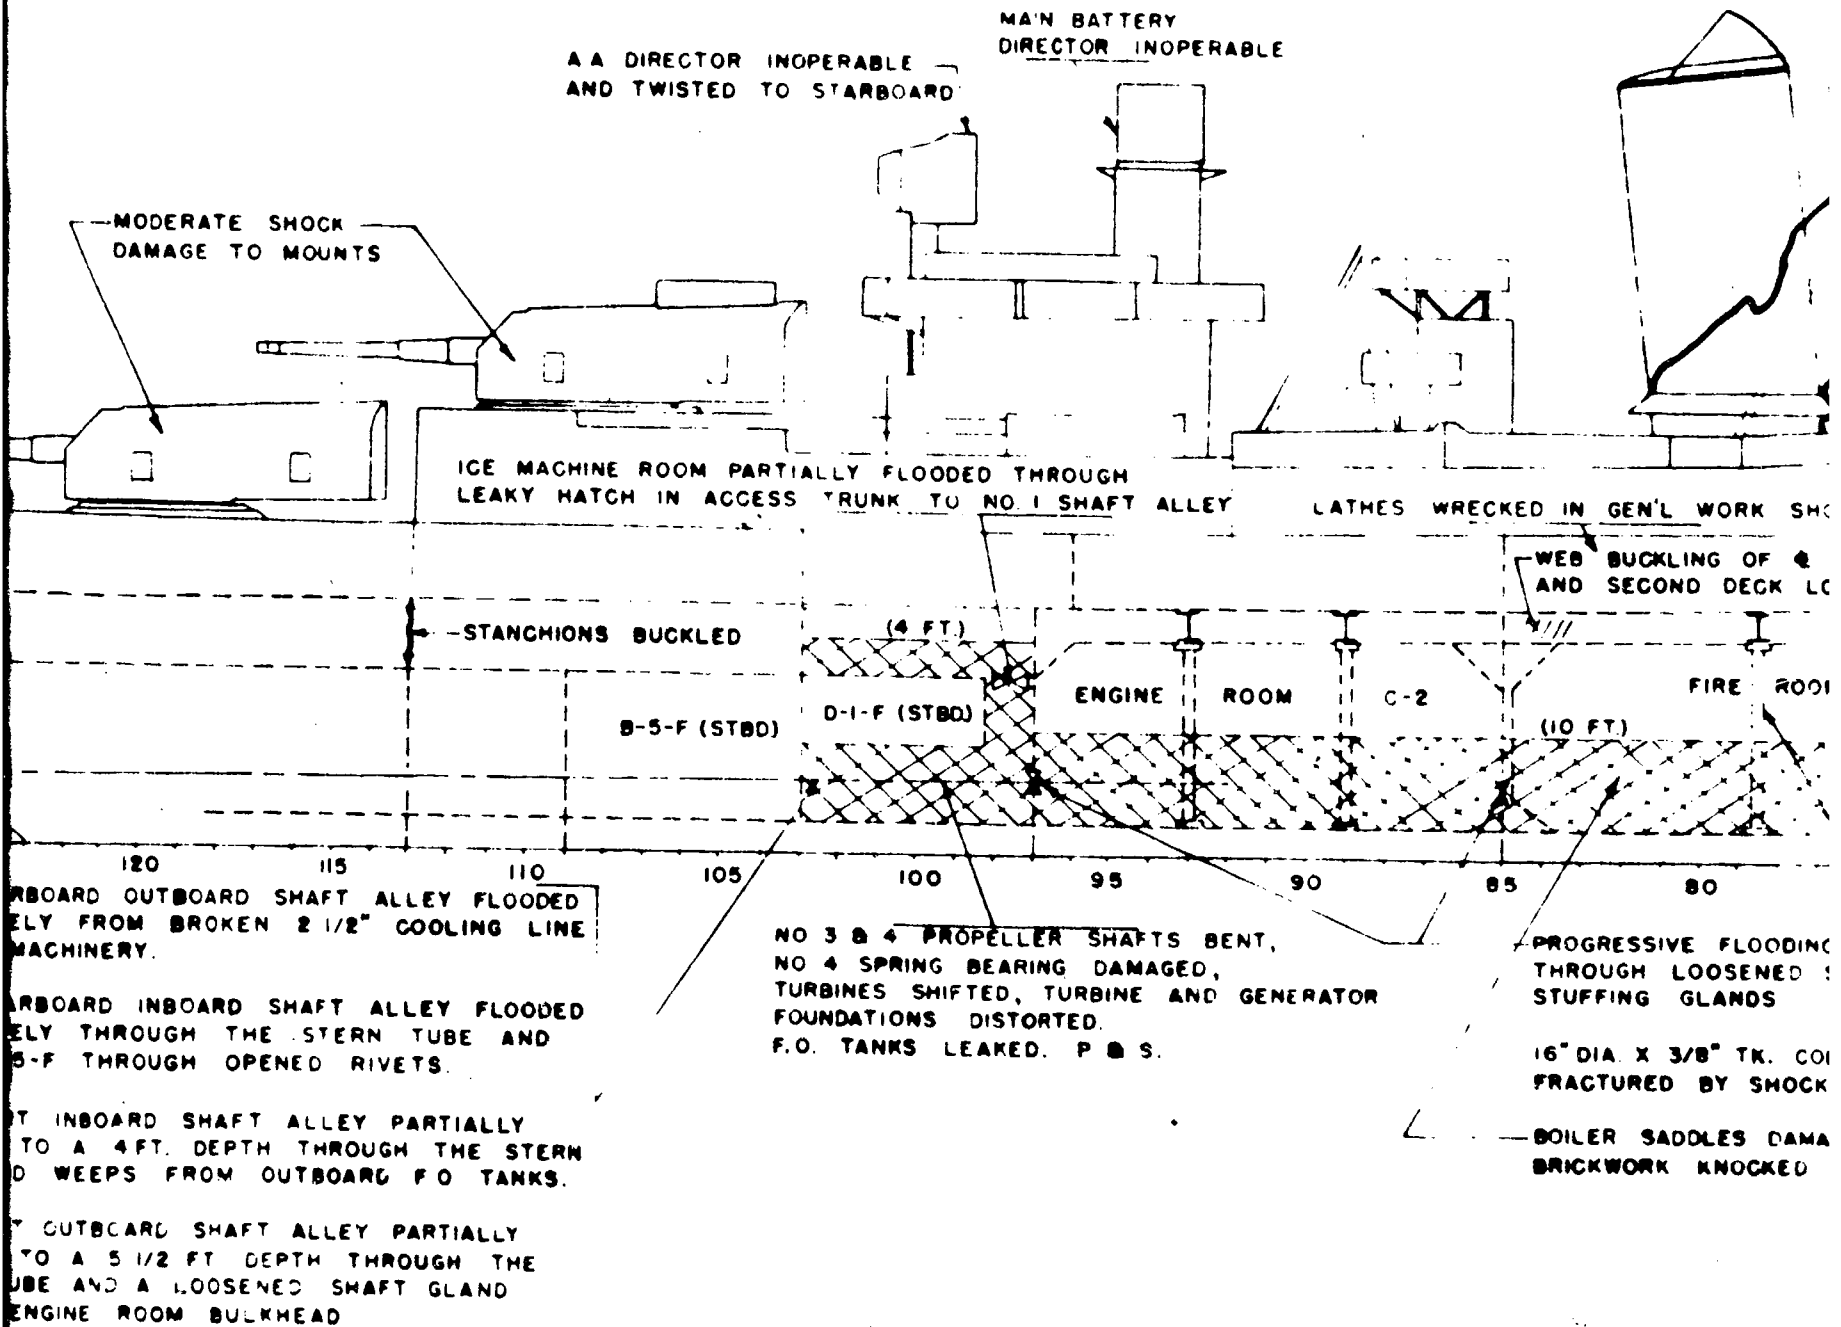
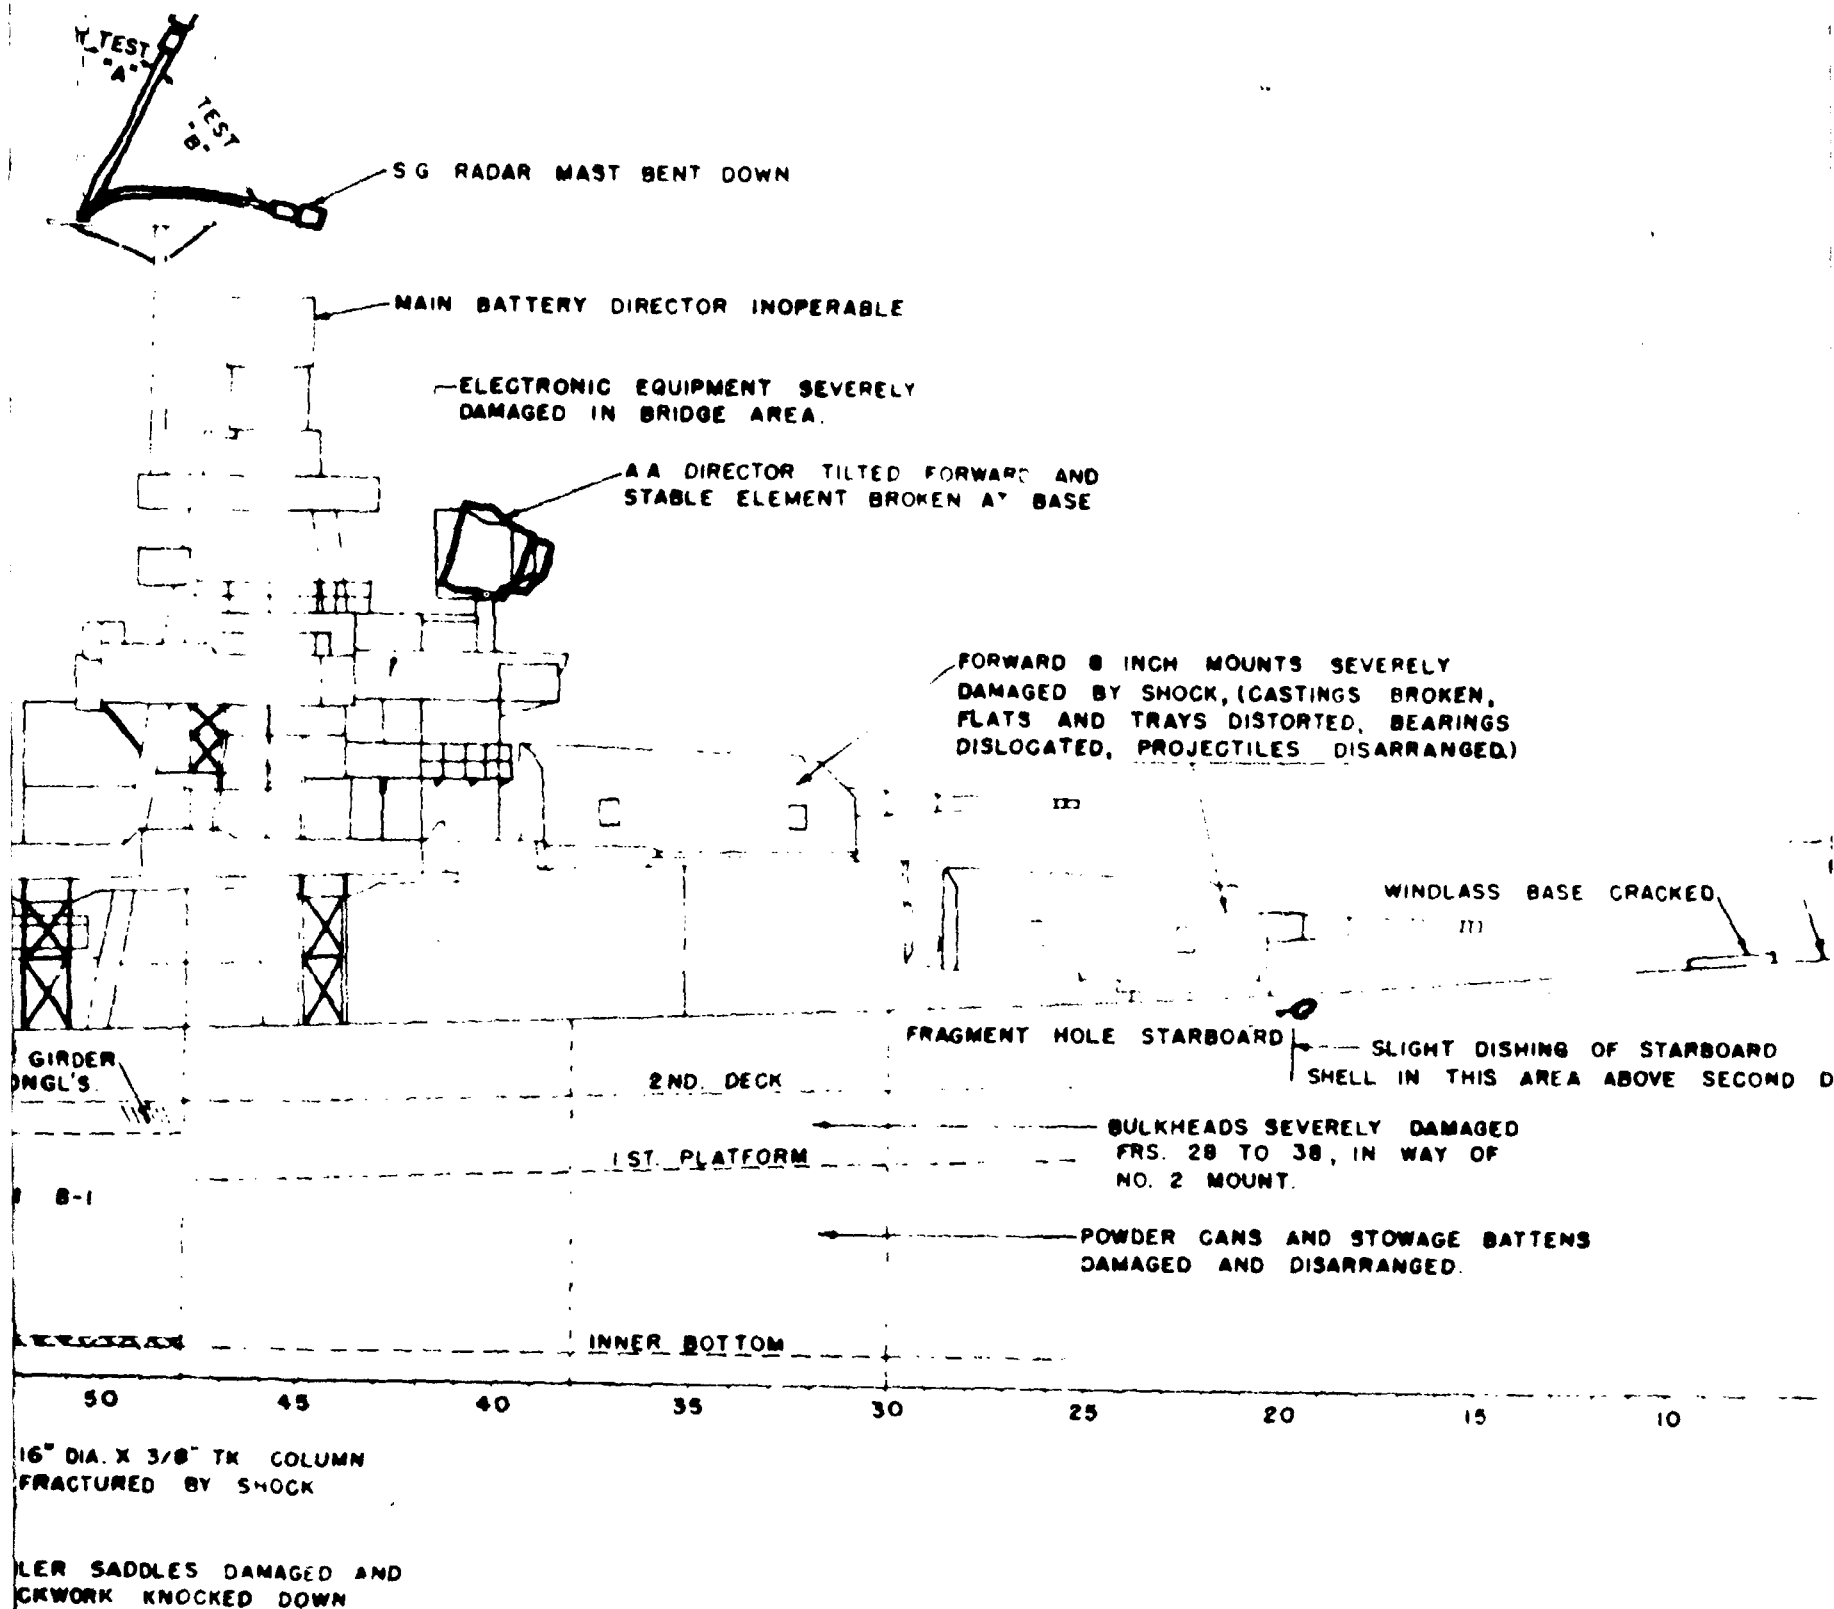
BOILER SADDLES DAMAGED AND
BRICKWORK KNOCKED DOWN

VERELY
BROKEN,
BEARINGS
(ARRANGED)
